TESTING OF THE WEBGIS TOOL FOR DELIVERABLE D.T2.2.1

VIPAVALLEY / SLOVENIA

Version 1
01 2021

Name of PP(s): PP7 - UIRS

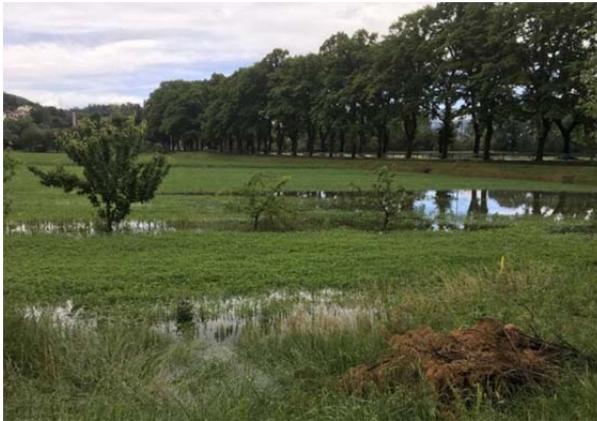
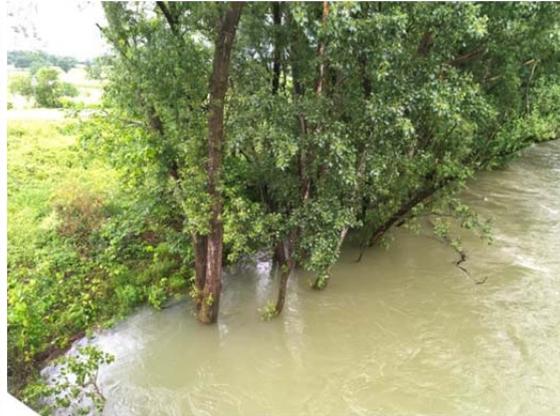
Vipava, linden avenue, floods in June 2020 (left).

Velike žablje, Vipava flooding in June 2020 (right).
