STRENGTHening resilience of Cultural Heritage at risk
in a changing environment through proactive
transnational cooperation

NEWSLETTER #4

NOVEMBER-FEBRUARY 2021/2022

**Spotlight & Focus: Applying the WebGIS tool for Risk Management, an elaborate Case Study on Zichy Mansion by the Lake Balaton Development Coordination Agency, Hungary**

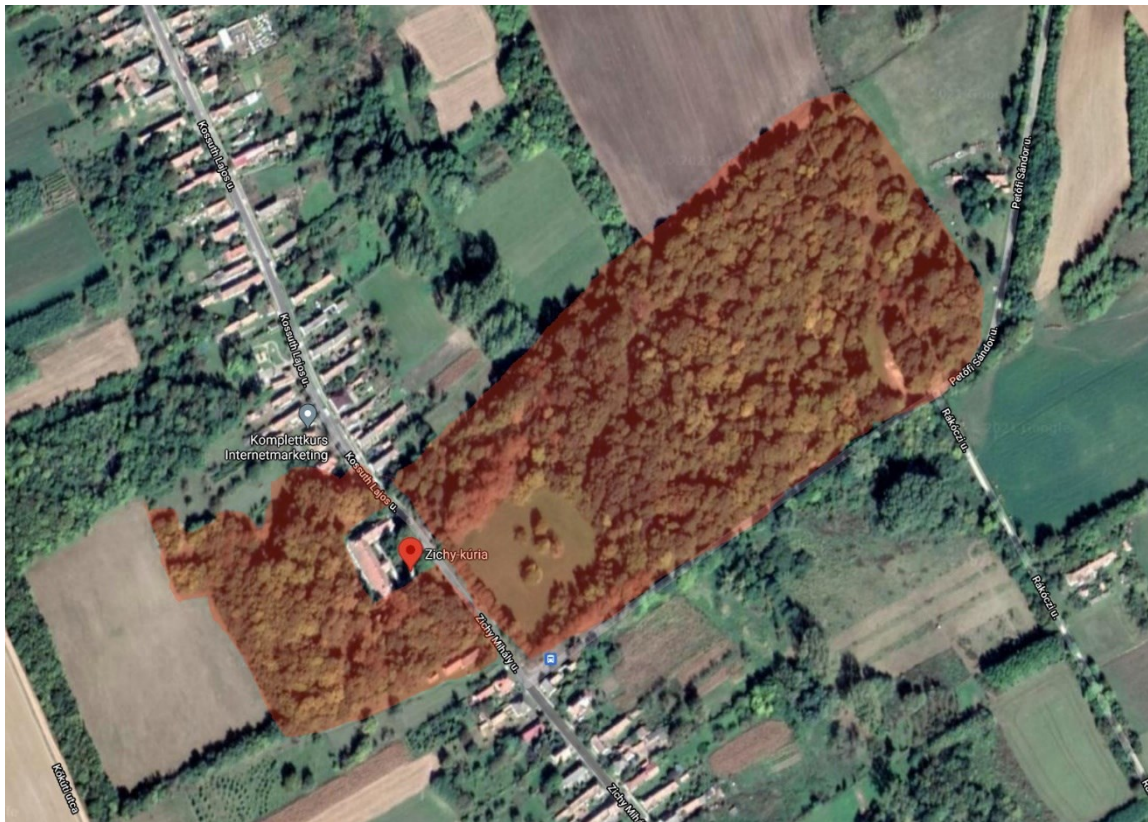
The building is surrounded by a park broken into two segments, (see picture below, in which the park segments are marked with red, the red dot represents the building itself). The park was planted around 1820. The park is a nature reserve with significant cultural and historical values. The 12-

hectare park is divided by the village traffic road and the Zala stream. The mansion is surrounded by spruce trees in the upper park, and the lower park is surrounded by a row of horse chestnuts (Aesculus hippocastanum). There are nine protected tree species and 16 protected bird species in the park, which is under landscape protection, so *it is part of the cultural landscape at Lake Balaton*.

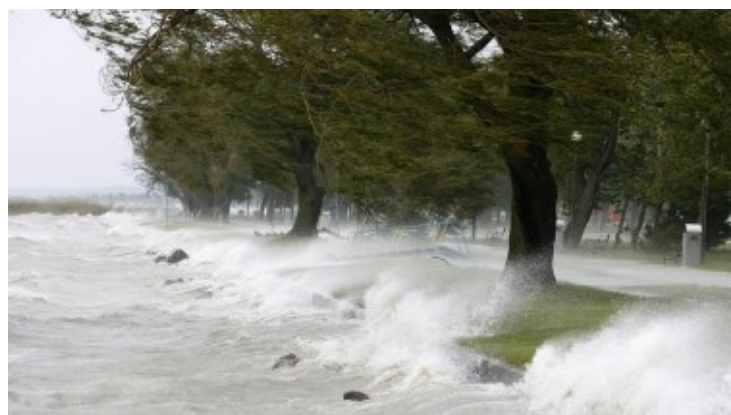
Heavy and damaging winds are a decade long problem in the greater Lake Balaton area. The effect of wind on the lake itself is especially interesting: strong wind gusts tend to „push” the water from one end of the lake from another. This so called „swing” could result in an increase/decrease of 10-20 cm water level (depending on the point of measure).

The days with 90+ km/h wind speeds almost doubled, the days with 110+ km/h wind speeds tripled in the last 20 years. Strong wind gusts alone are enough of a threat but they are almost always coupled with heavy rainfall and storm activity, which increases the likelihood of flash floods, fallen trees, damages to infrastructure etc.

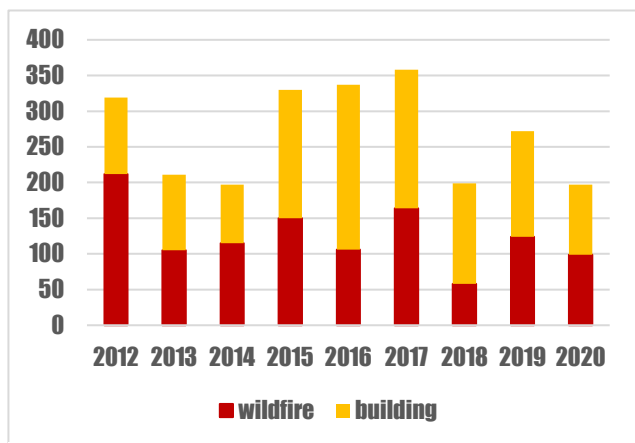
Fires in the larger South-Balaton area where the mansion itself is located. „Wildfire” means every incident where firefighters have to extinguish a fire affecting a natural environment (mainly forest, but also areas with foliage, agricultural areas with crop etc.). „Building” means every incident where firefighters have to extinguish a fire affecting a built environment (any type of building, infrastructure).

For the sake of this case study the fires were divided into two categories. Wildfires (aside from a few years) are less common in this area, but overall they give a significant portion of firefighter’s work.

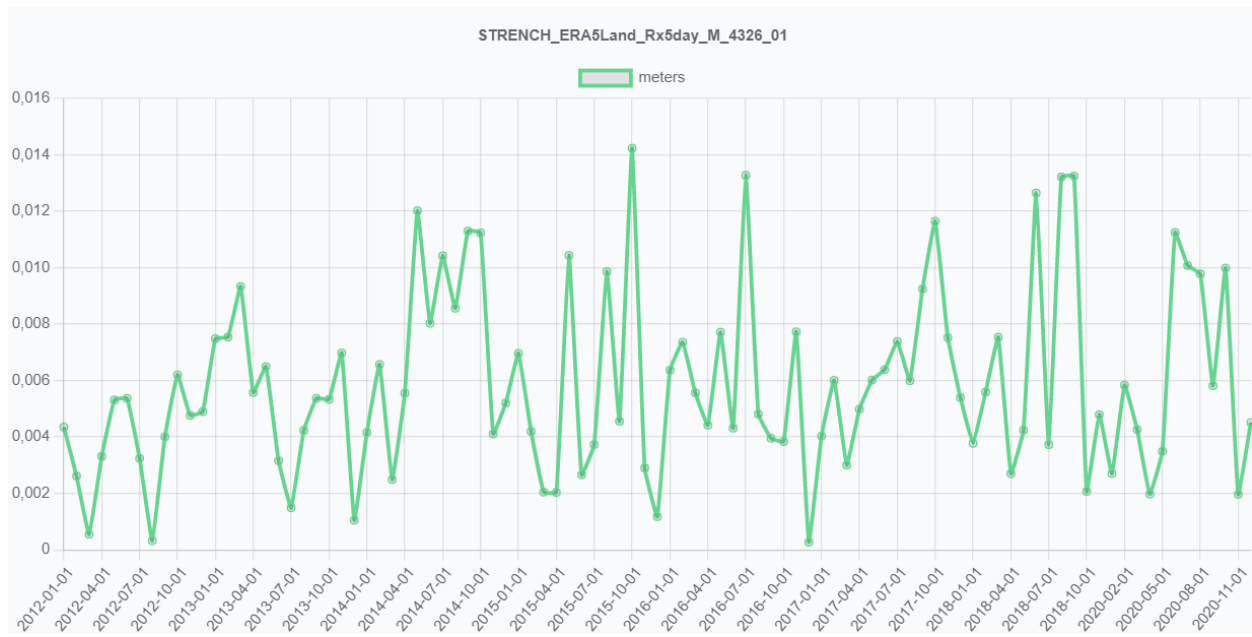
Climate index: Rx5day / Dataset: ERA5-Land 2012–2020

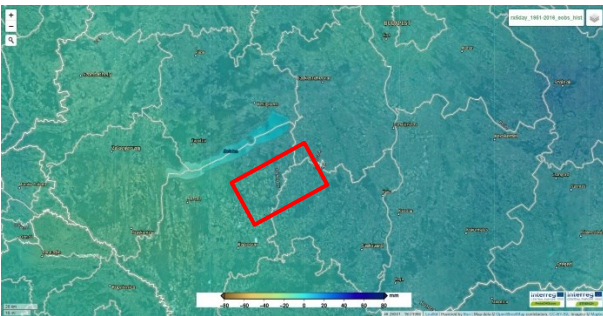
Map for the past dataset on Rx5day

Map for the near future dataset on Rx5day

Map for the far future dataset on Rx5day

The two future projections show the southern Lake Balaton region being in the 12 and then the 20-25 mm range.

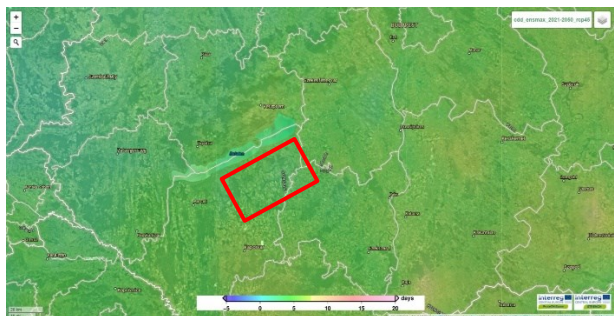
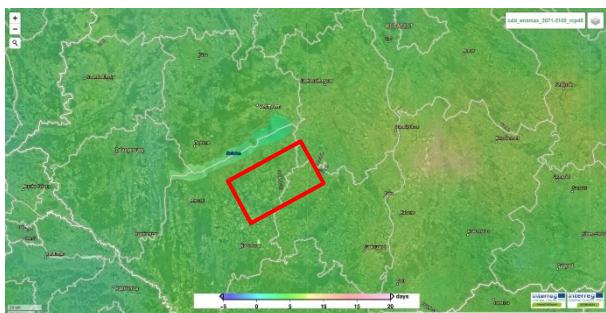
Map for the past dataset on CDD

Map for the near future dataset on CDD

Interestingly there is no significant increase in an 80 years timespan. In this instance, judging from the visual representation, the risk stays more or less the same, so we must plan accordingly (more on that later, see Chapter 6).

Map for the far future dataset on CDD
