# TRANSNATIONAL MODEL OF SUSTAINABLE PROTECTION AND CONSERVATION OF HISTORIC RUINS

Best practices handbook

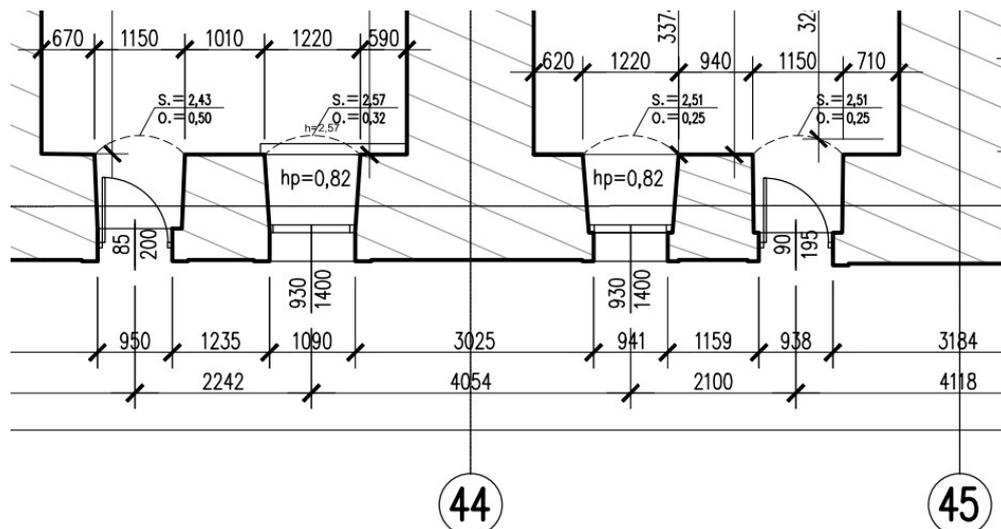
Figure 1. Fragment of the final stocktaking of Kłodzko Donjon Fortress - a horizontal cross-section of the "0" storey - the stocktaking made using a computer drawing software.

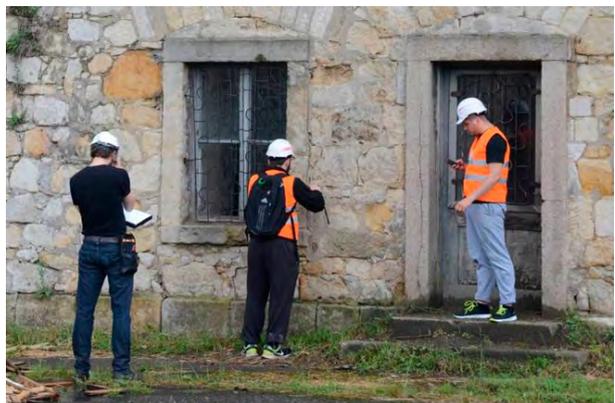
Photo 1. Traditional measurements of the elevation of the Kłodzko Donjon Fortress

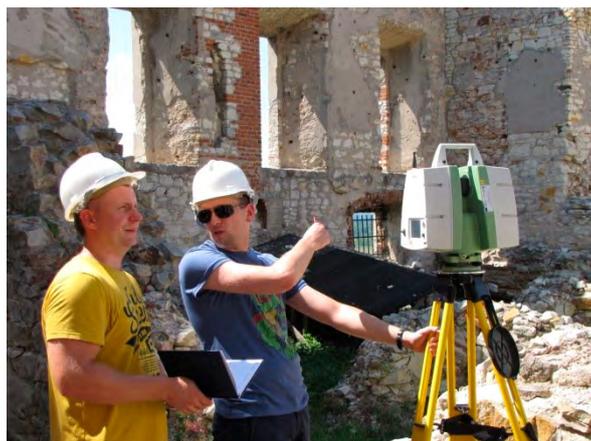
Photo 4. Leica ScanStation C10 while taking measurements

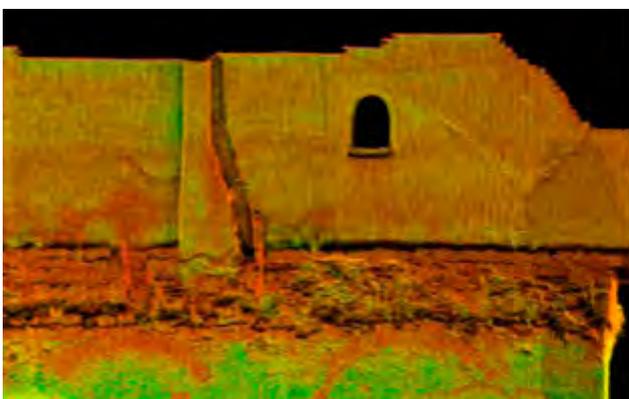
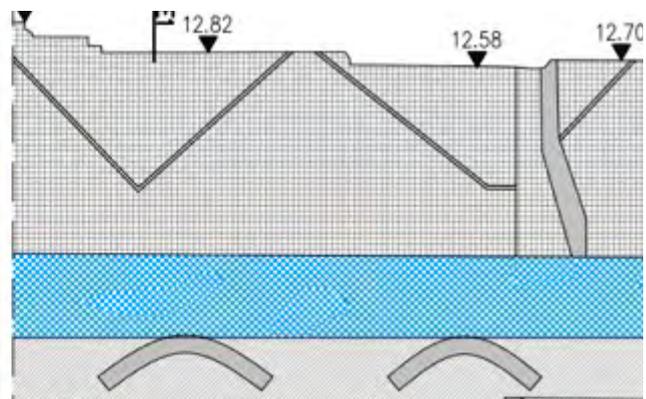
Figure 4. A view of the facade of Janowiec castle developed on the basis of a 3D scan

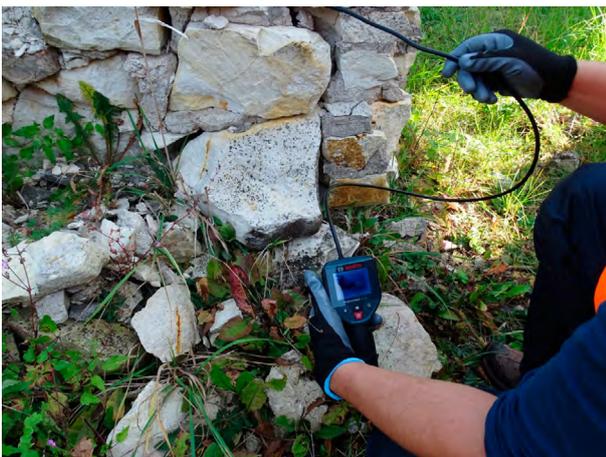
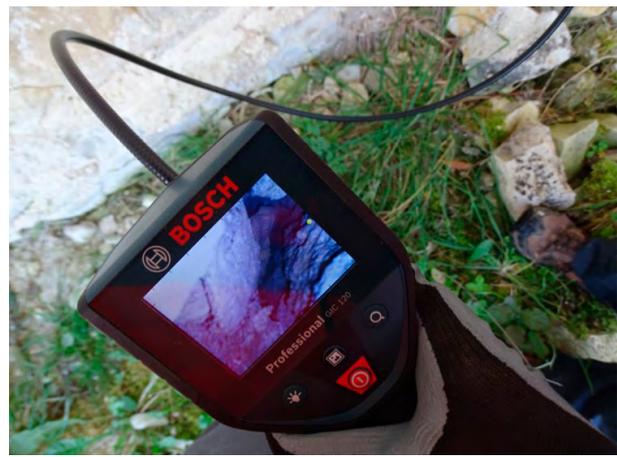
Photo 5. The endoscopic camera

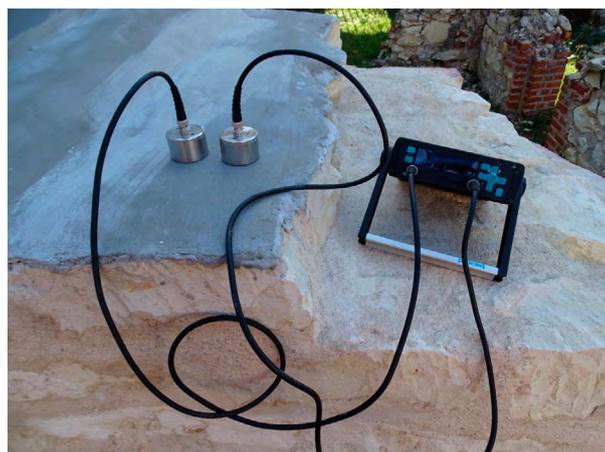
Photo 6. Ultrasonic testing equipment

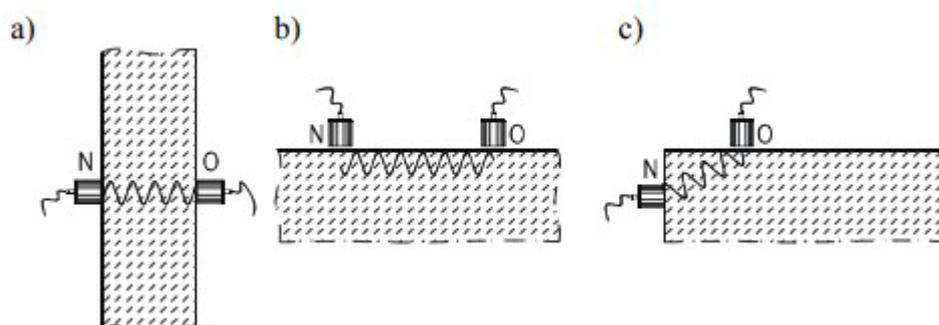
Figure 5. Scheme of performing measurements and distribution of probes<sup>8</sup>

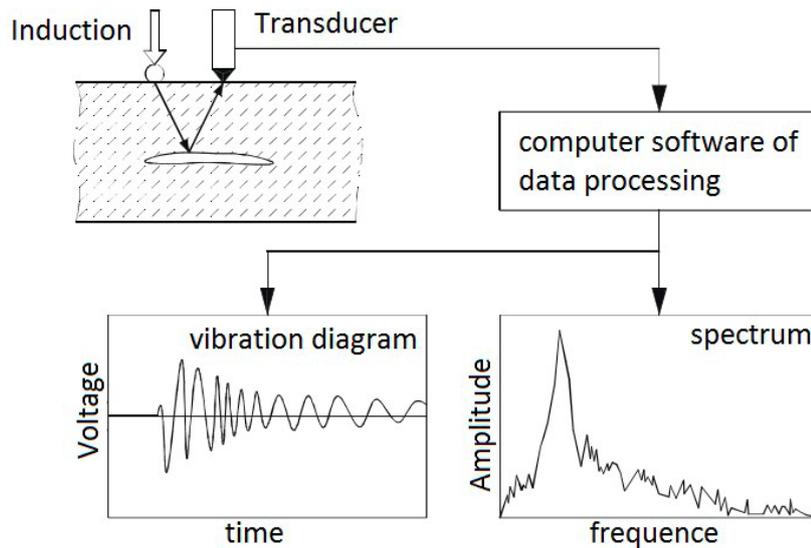
Figure 6. Scheme of the test<sup>9</sup>

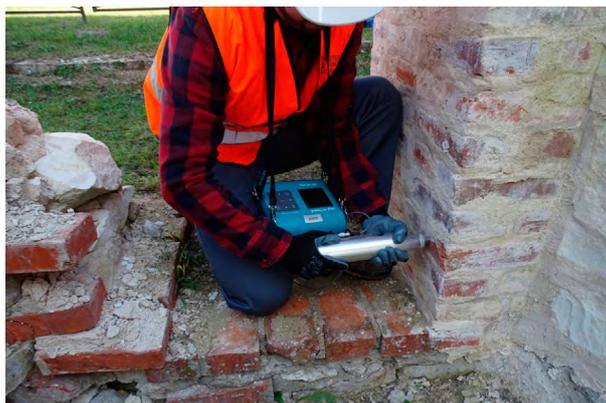
Photo 8. Sclerometric test

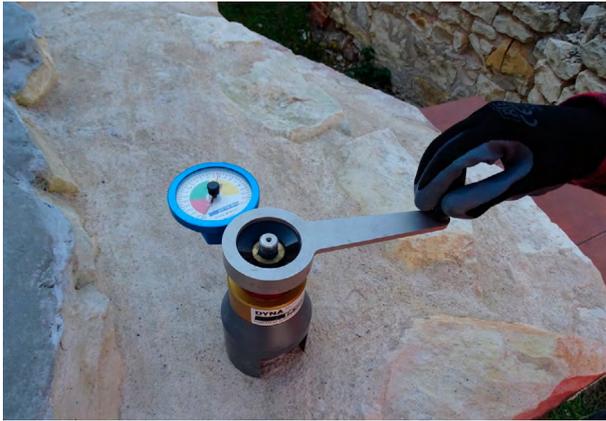
Photo 9. Photo of a peel strength test.

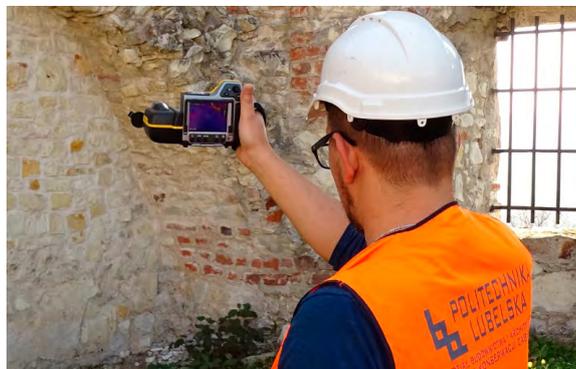
Photo 11. Thermal camera during a test

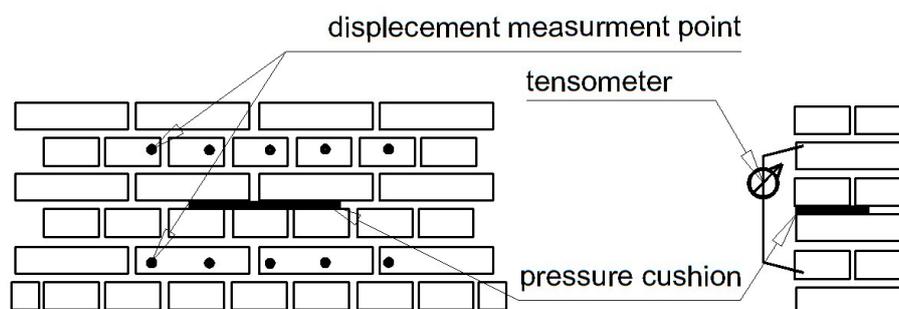
The method of determining stresses in the masonry by means of pressure cushions is very simple. The first step is to properly arrange the control points and measure the distance between them (with an accuracy of 0.001mm). Next, a groove in which the pressure cushion is placed should be made (by cutting or notching) between the measuring points. The pressure cushion is made of a metal sheet and its shape depends on the shape of the groove made. Next, the cushion is filled with a liquid and the stresses caused by filling the cushion and increasing its volume in the masonry are monitored on a current basis using a manometer. Measurements between control points are performed on a regular basis. The value of the manometer must be read when the values of the distance from before the groove was made are equalized. After proper reduction of the value depending on the shape of the cushion and the pressure surface of this cushion, the value obtained is the value of stresses in the masonry. Based on the analysis of the technical literature, the measurement error was estimated at no more than 33%.

Figure 7. Stress measurement in the masonry with a single pressure cushion

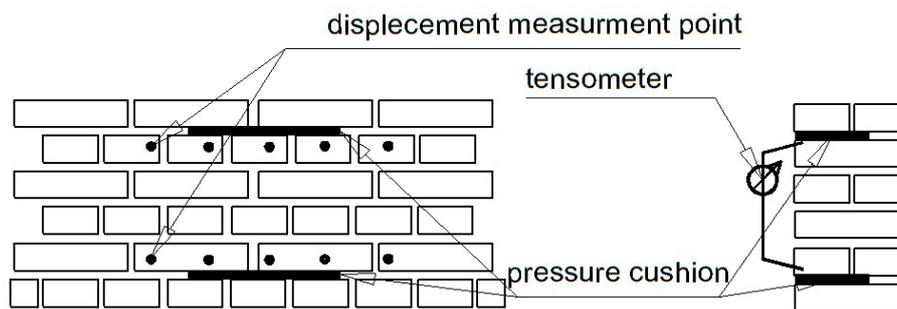
Measuring the deformability of the wall consists in making two grooves and fixing cushions in them. control points between the grooves should be marked and distance measurements on them should be taken. Determination of deformability of the wall consists in describing the relationship of stress increase to strain increase (Young's modulus) in the masonry structure.

Figure 8. Measuring the deformability of the wall and possibly its strength by means of two pressure cushions

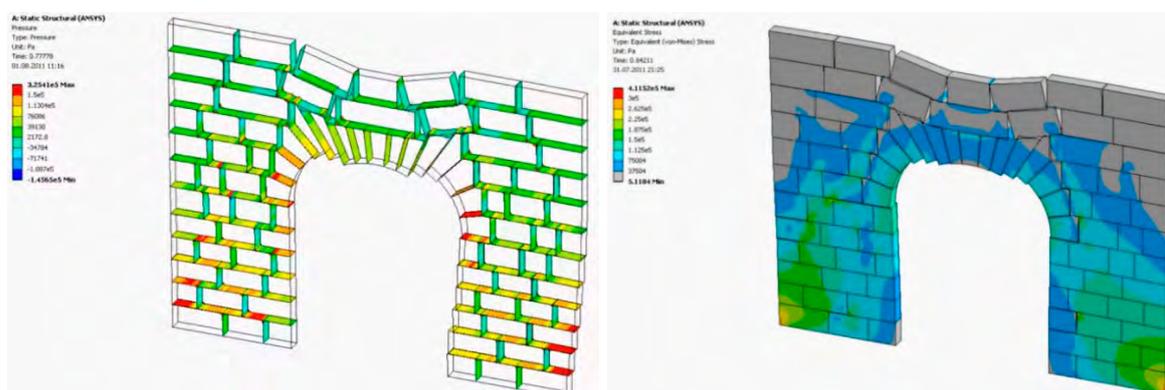
Figure 9. View of stresses in a wall element and joints<sup>10</sup>

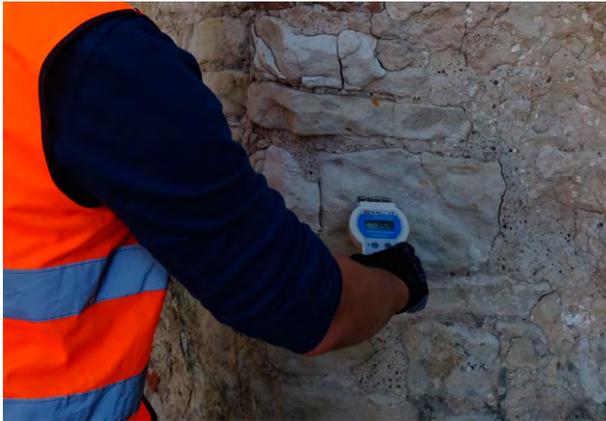
Photo 13. The LB-796 dielectric moisture meter.

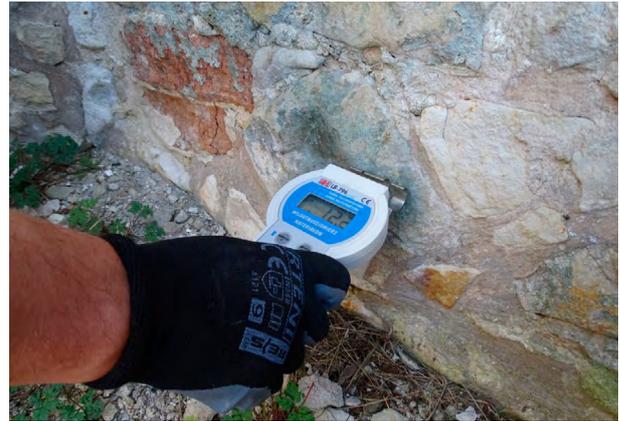
Photo 14. The LB-796 dielectric moisture meter.

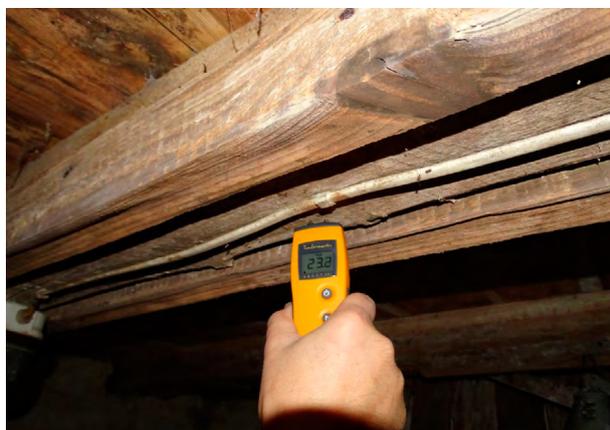
Photo 15. The Protimeter Timbermaster Moisture Meter hygrometer.

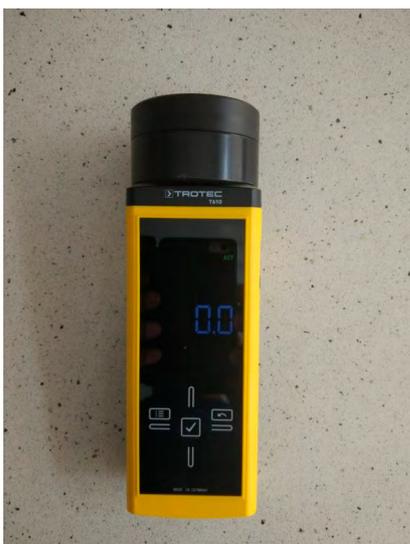
Photo 17. The TROTEC T610 hygrometer

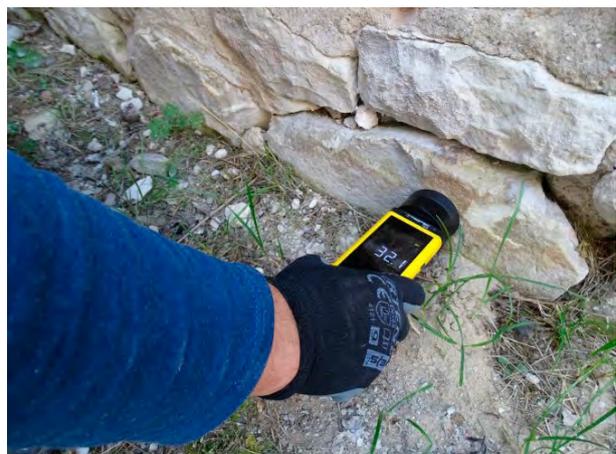
Photo 18. Moisture measurement by the microwave method

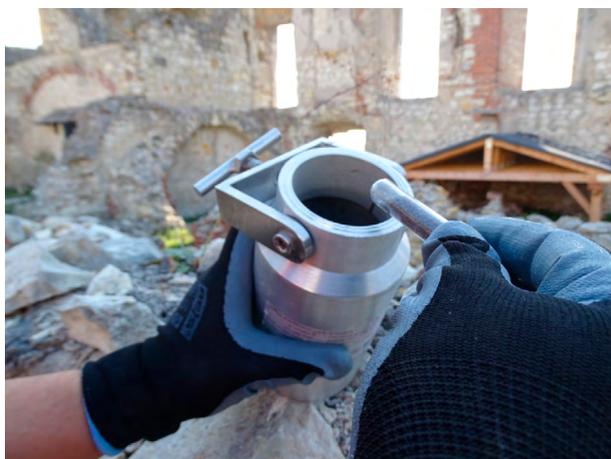
Photo 19. The WK-1 hygrometer

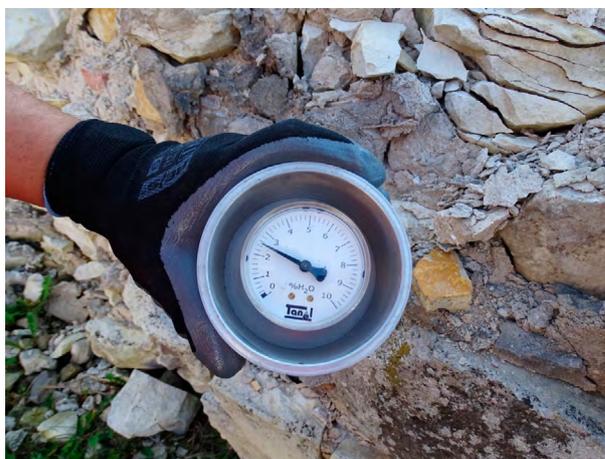
Photo 20. Investigation of moisture by the carbide method, reading of the acetylene pressure in the tank

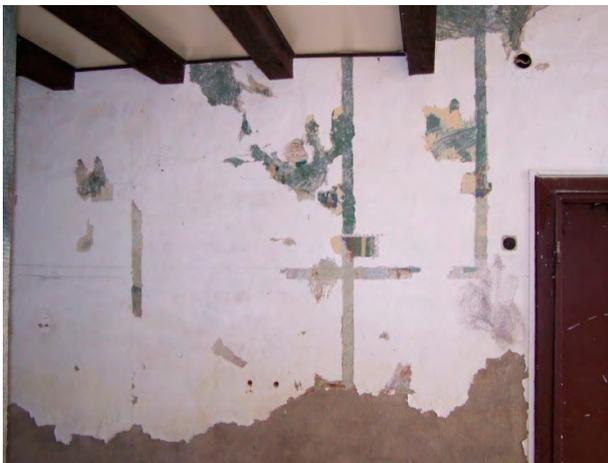
**Photo 21.** *Strip outcrop with probes revealing bottom layers of painting.*

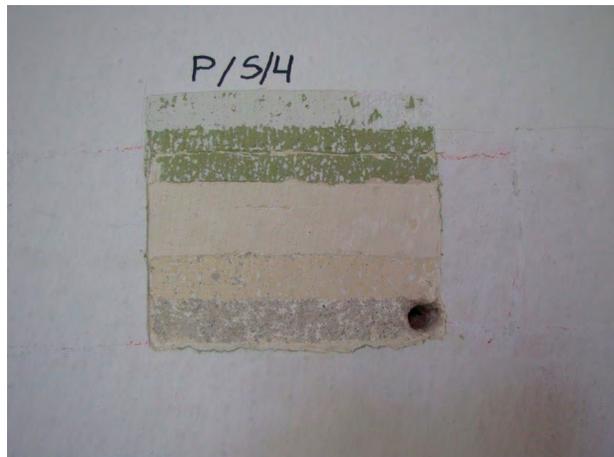
**Photo 22.** *Stepped probe showing the arrangement of layers of plasters and paintings on the wall.*

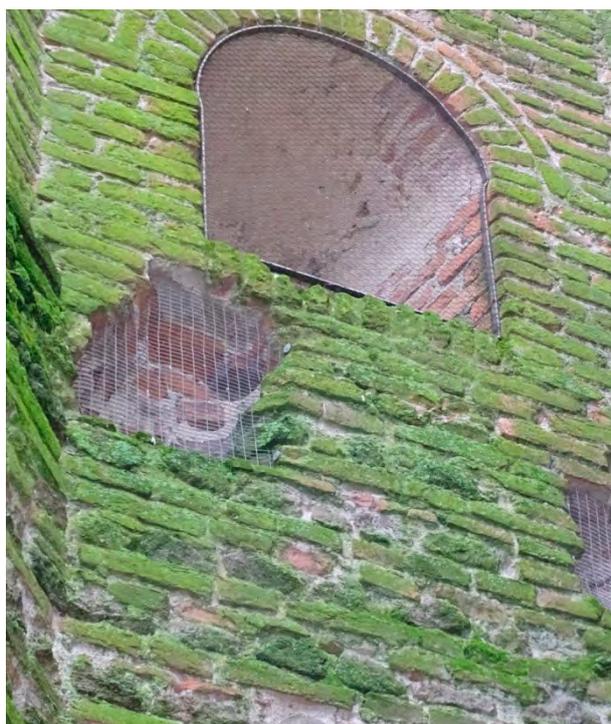
**Photo 23.** *Algae colonies on a moist ceramic brick wall.*

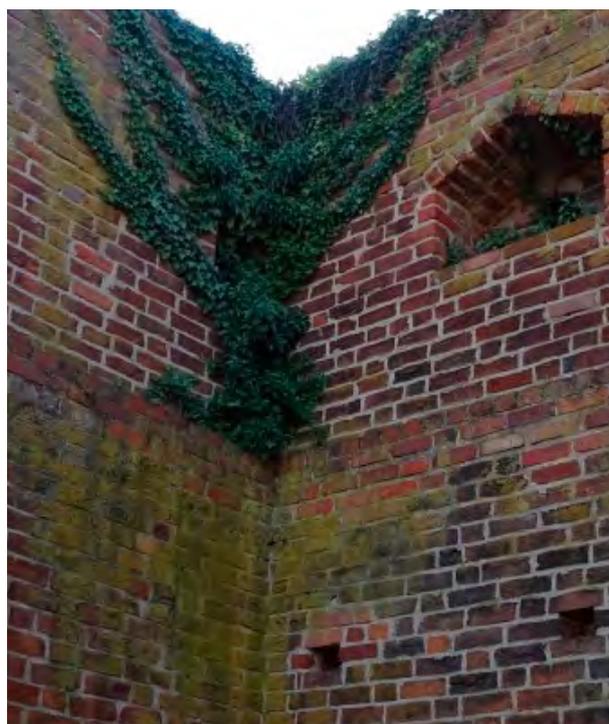
**Photo 24.** *The development of algae and lichen in the corner of the wall directly under the ivy, which grows on the wall and the crown.*

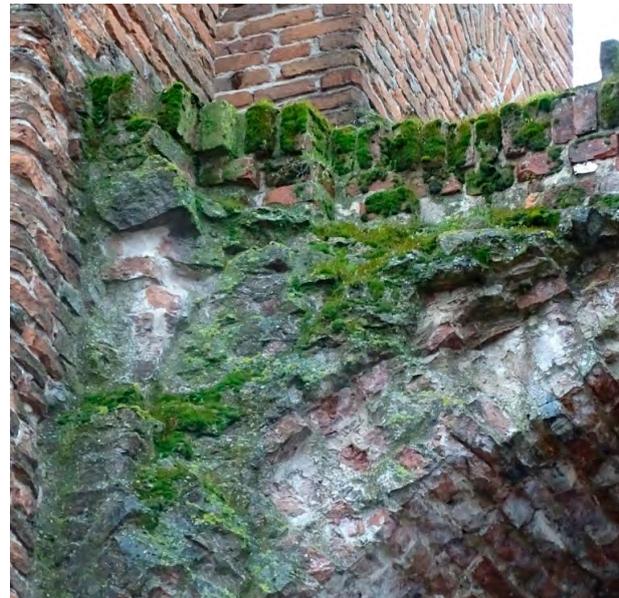
**Photo 28.** *Moss and algae, which overgrow the crown and the face of the wall.*

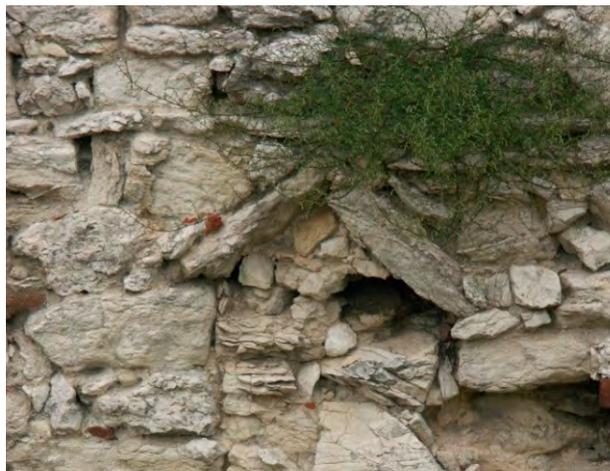
**Photo 29.** Photograph of a heavily sunlit southern façade. The development of vegetation in the wall crevices.

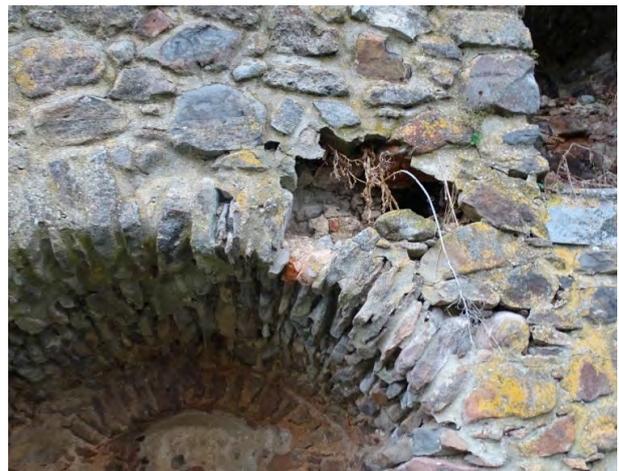
**Photo 30.** Damage to the face of the wall associated with the growth of the root system of low vegetation.

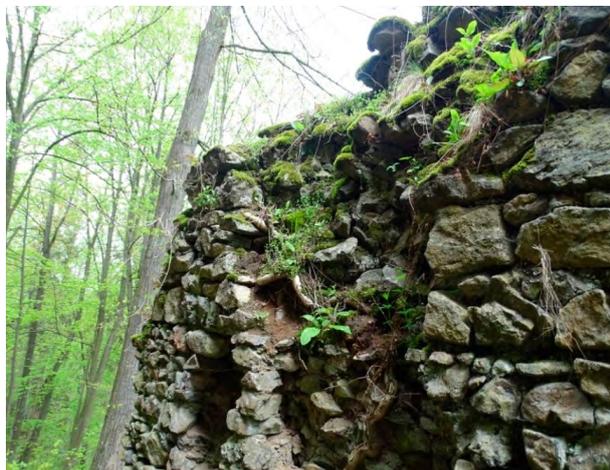
**Photo 31.** The crown and the face of a curtain wall overgrown with annual and perennial vegetation.

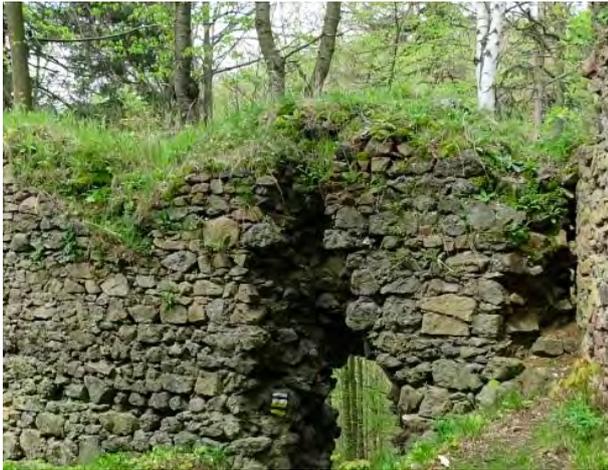
**Photo 33.** *The low crown of the wall completely overgrown with greenery. The tight layer of humus and greenery prevents evaporation of the moisture retained in the wall.*

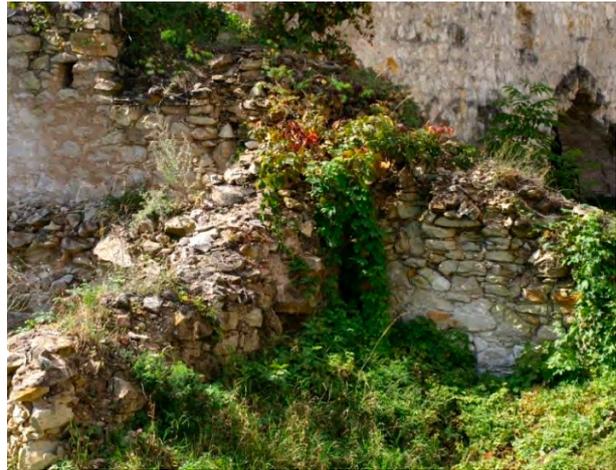
**Photo 34.** *A wall relic covered with vegetation. A large amount of greenery causes the illegibility of the ruin.*

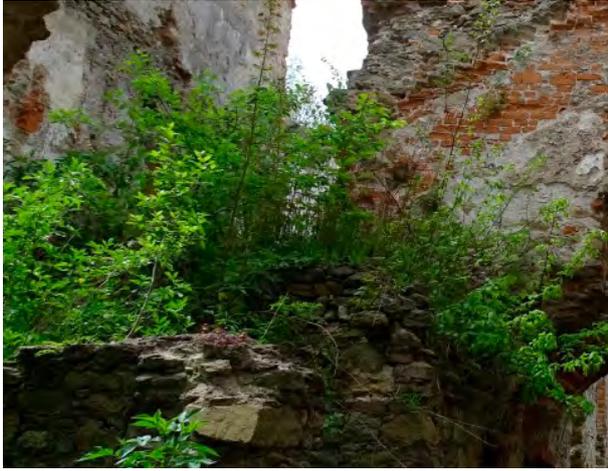
**Photo 35.** A fragment of the vault intensely overgrown with shrubs.

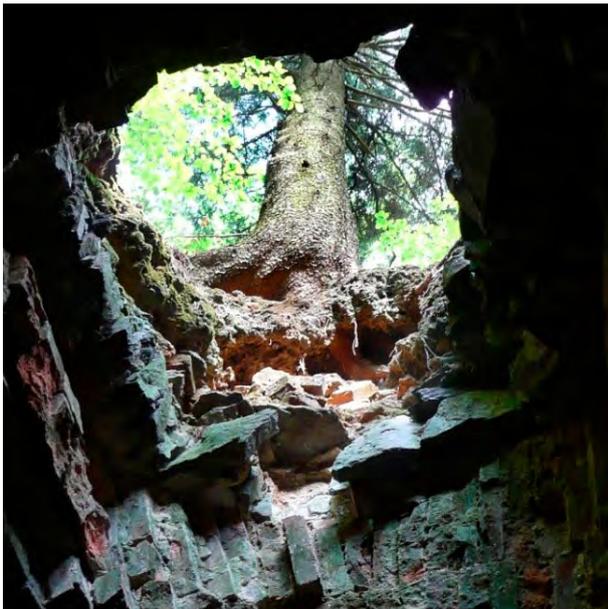
**Photo 39.** A vault made of ceramic brick damaged by roots.

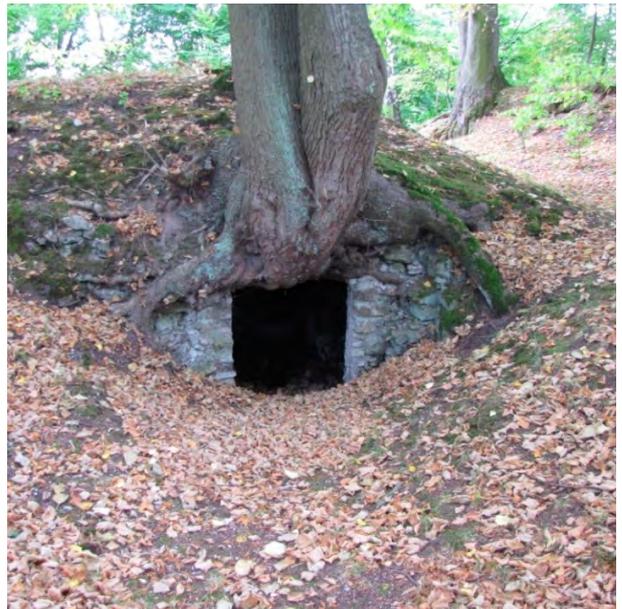
**Photo 40.** A huge tree and its root system, which has overgrown a stone vault.

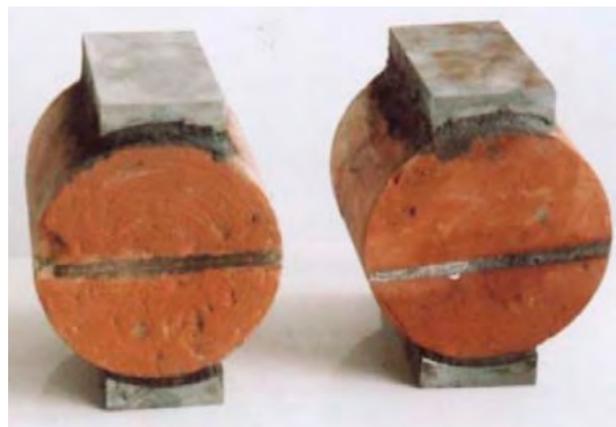
Photo 42. Samples prepared for testing.<sup>19</sup>

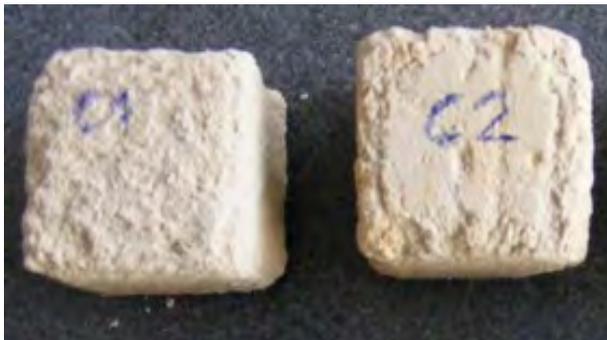
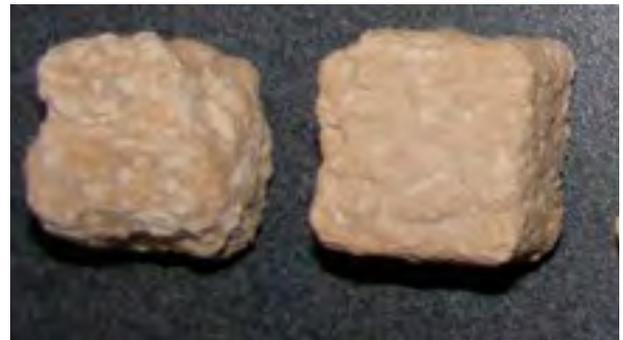
Photo 63. Resistance test for salt crystallization. Limestone rock samples after 2 cycles.

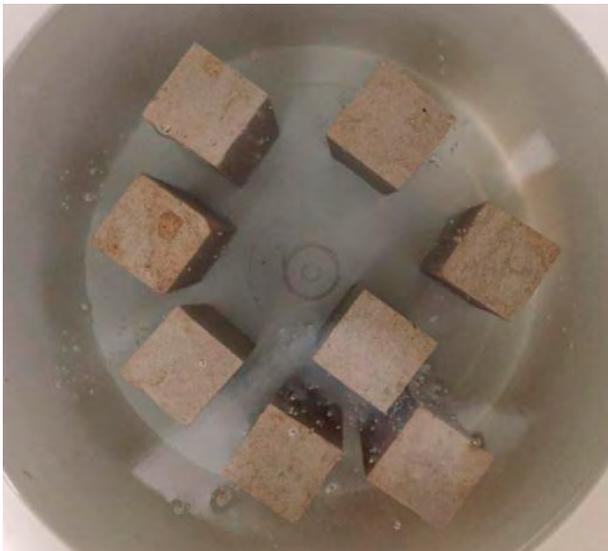
Photo 67. Frost resistance test. Soaking of sandstone samples.

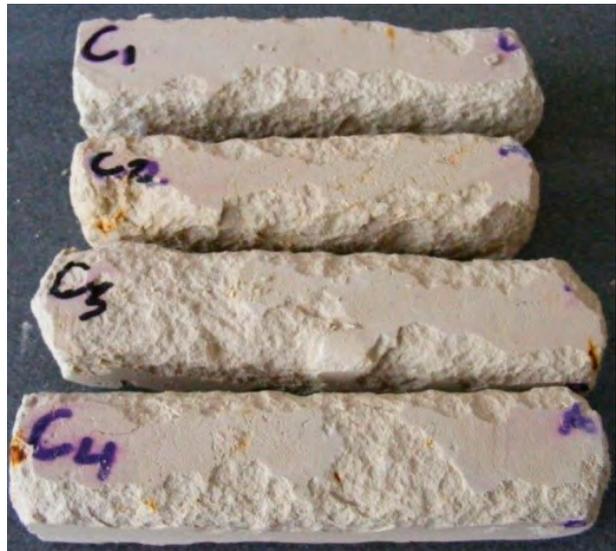
Photo 68. Frost resistance test. Samples from limestone rock after 56 freezing cycles.

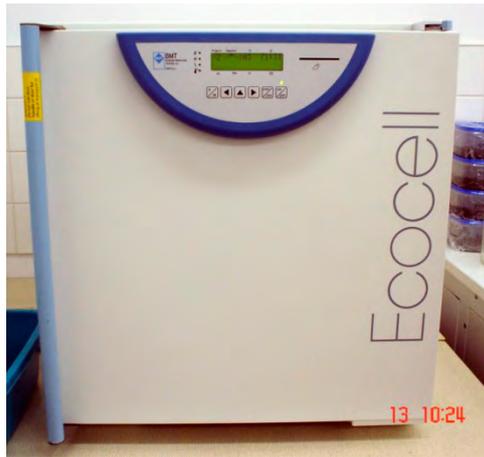
Photo 71. A laboratory dryer

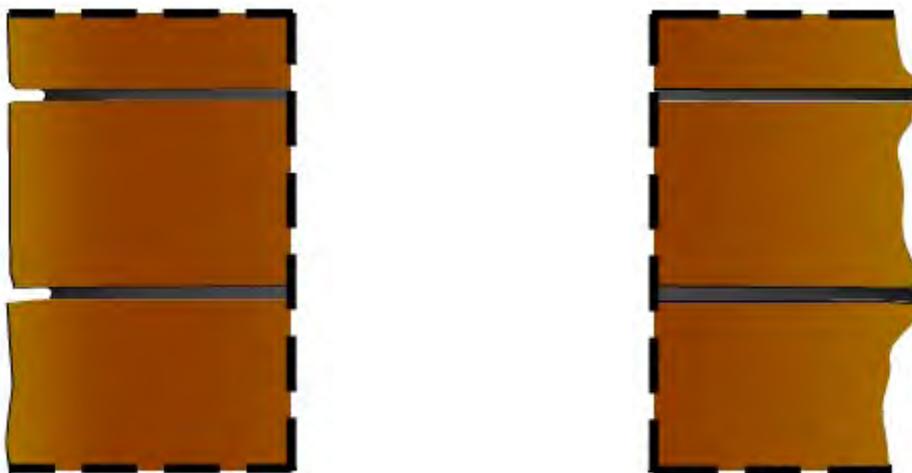
Destructive salt action can have multiple effects. With continuous transport of the salt solution, its crystallization takes place on the surface of the element. This poses a smaller immediate threat of destruction, but results in a significant deterioration of the surface aesthetics of the material. The salts on the surface of the material can crystallize in the form of stains, efflorescence, fluffy blooms, and glassy coatings. These forms depend on the type and amount of salt, as well as on the conditions under which the crystallization takes place.

**Figure 13.** Salt corrosion of the wall surface with mortar weaker than the masonry material. **Figure 14.** Salt corrosion of the wall surface with mortar stronger than the masonry material.

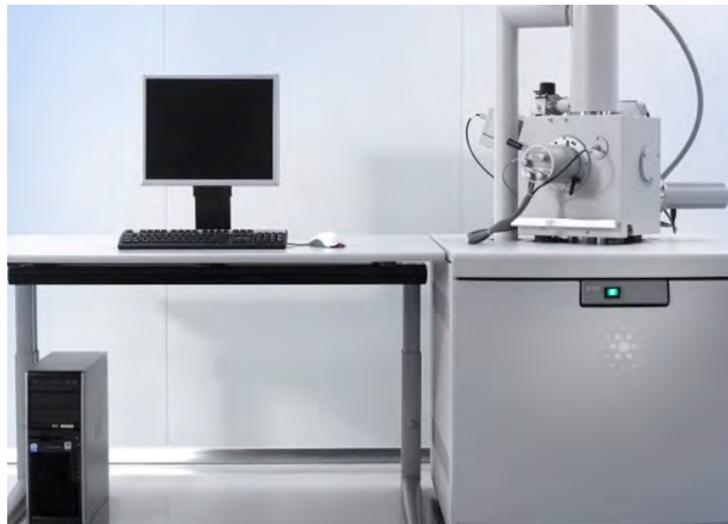
Photo 76. Scanning electron microscope with a detector - Quanta 250 FEG by FEI company, EDS detector by EDAX. WBiA laboratory of Lublin University of Technology

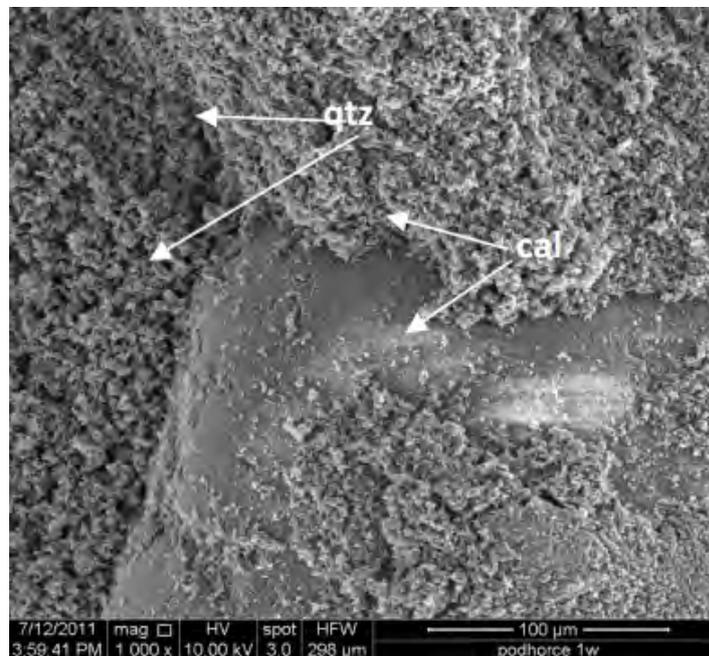
**Photo 77.** An image of the fracture of a lime mortar sample (SEM 800x) shows a porous compact mass of the lime binder (cal), in which few individual larger quartz grains are visible (qtz).

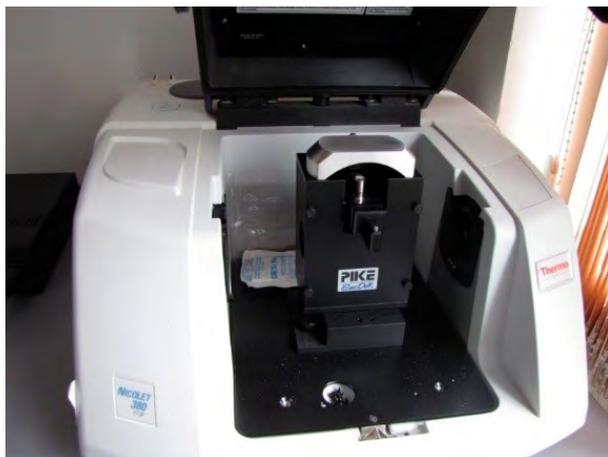
Photo 81. The infrared spectrometer - FTIR Nicolet. WBiA laboratory of Lublin University of Technology

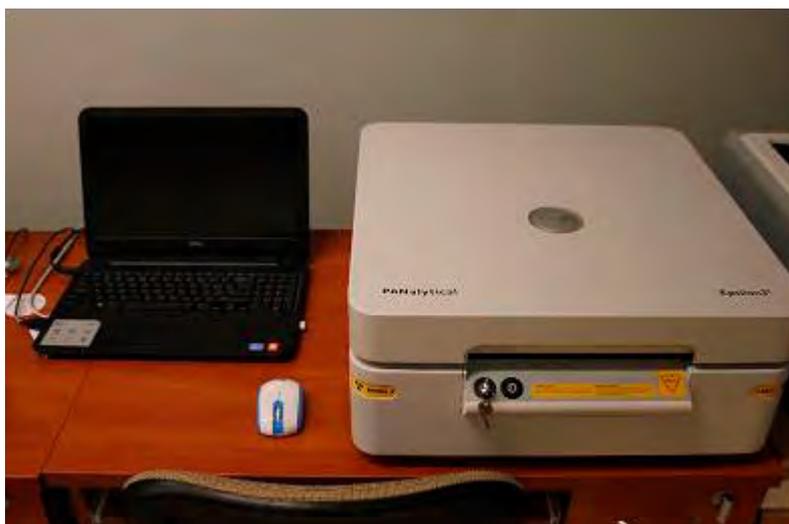
**Photo 82.** *The Epsilon 3 spectrometer by Panalytical. WBiA laboratory of Lublin University of Technology*

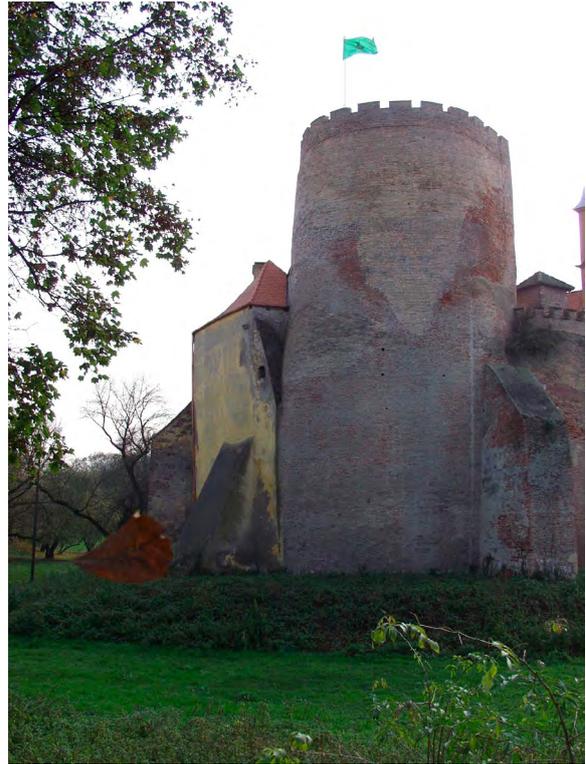
**Picture 10.** *The present state of the tower: the “stains” on top of the walls indicate the restored parts of the tower as well as areas with increased amounts of moisture in the walls*

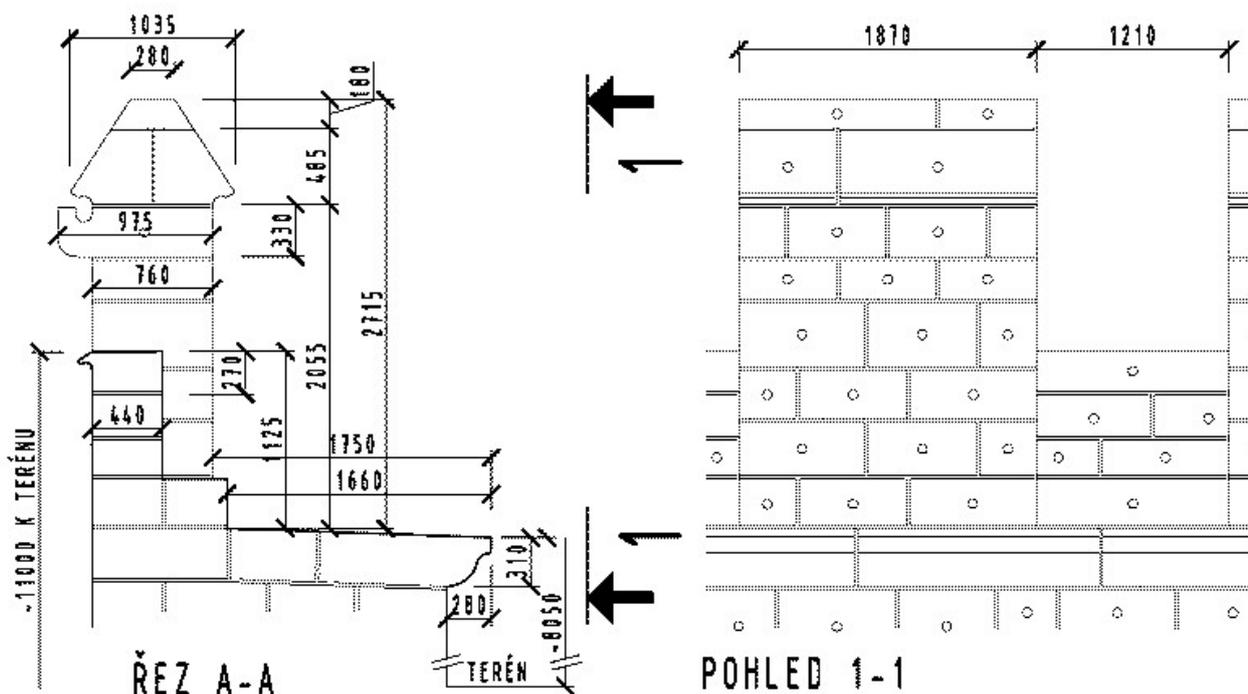
*A section and front view of the parapet wall situated on the eastern side of the castle*

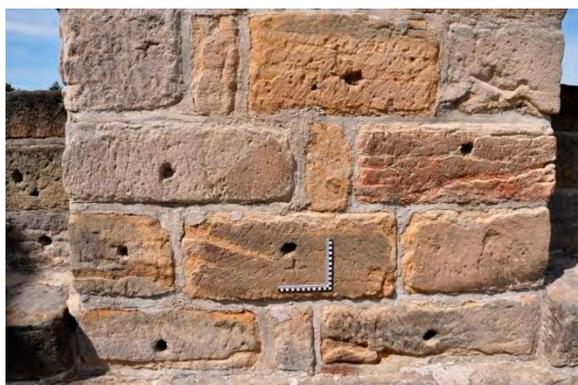
*Various traces on the surface of the wall: signs of transportation, tool marks, stonemason's mark, traces of weathering and aging*

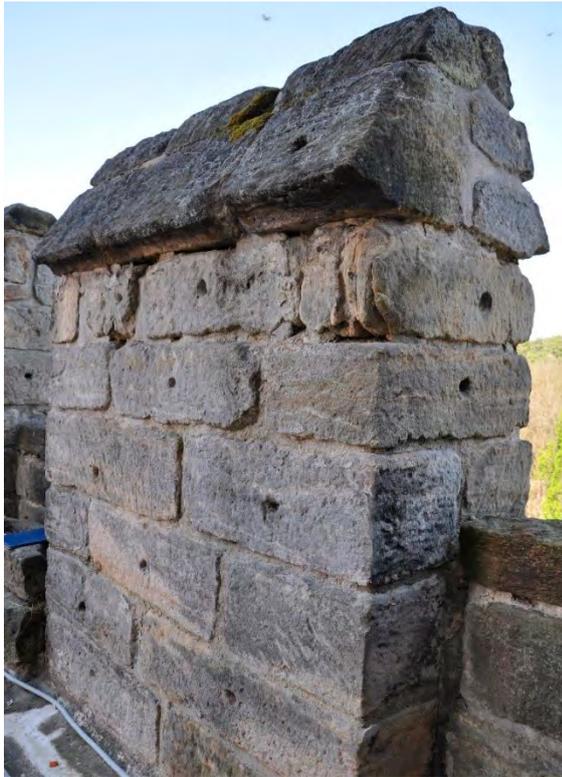
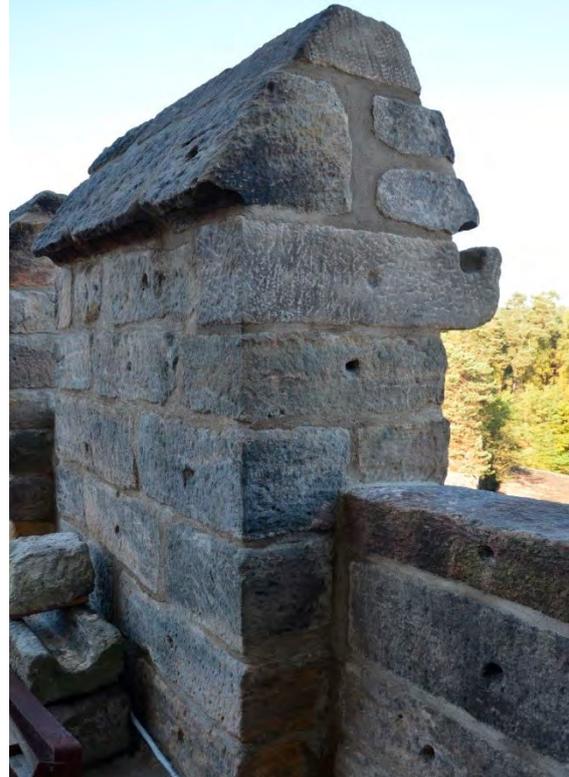
One of the merlons on the battlements before and after the repair

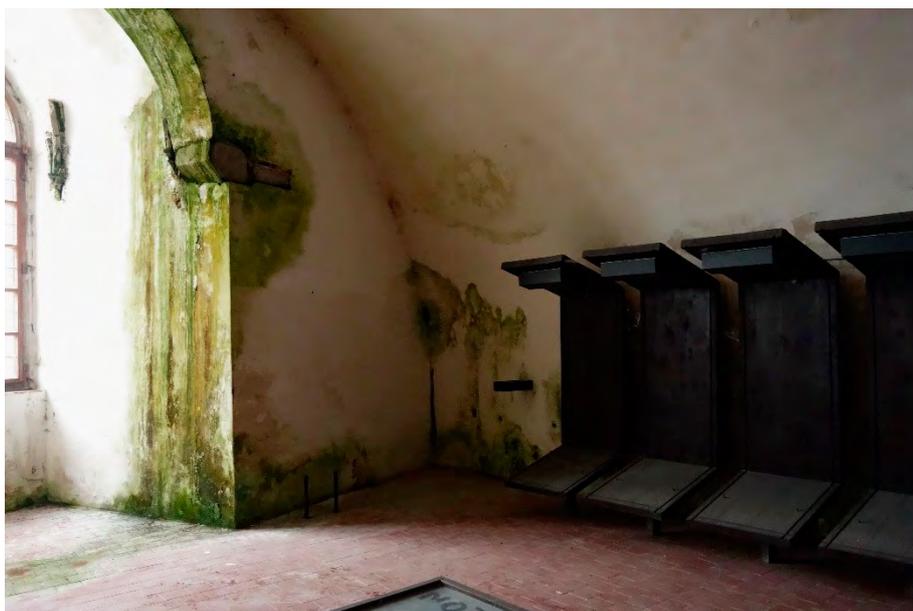
*High humidity in the interior of the Great Tower (photo Lucie Bláhová 2017)*

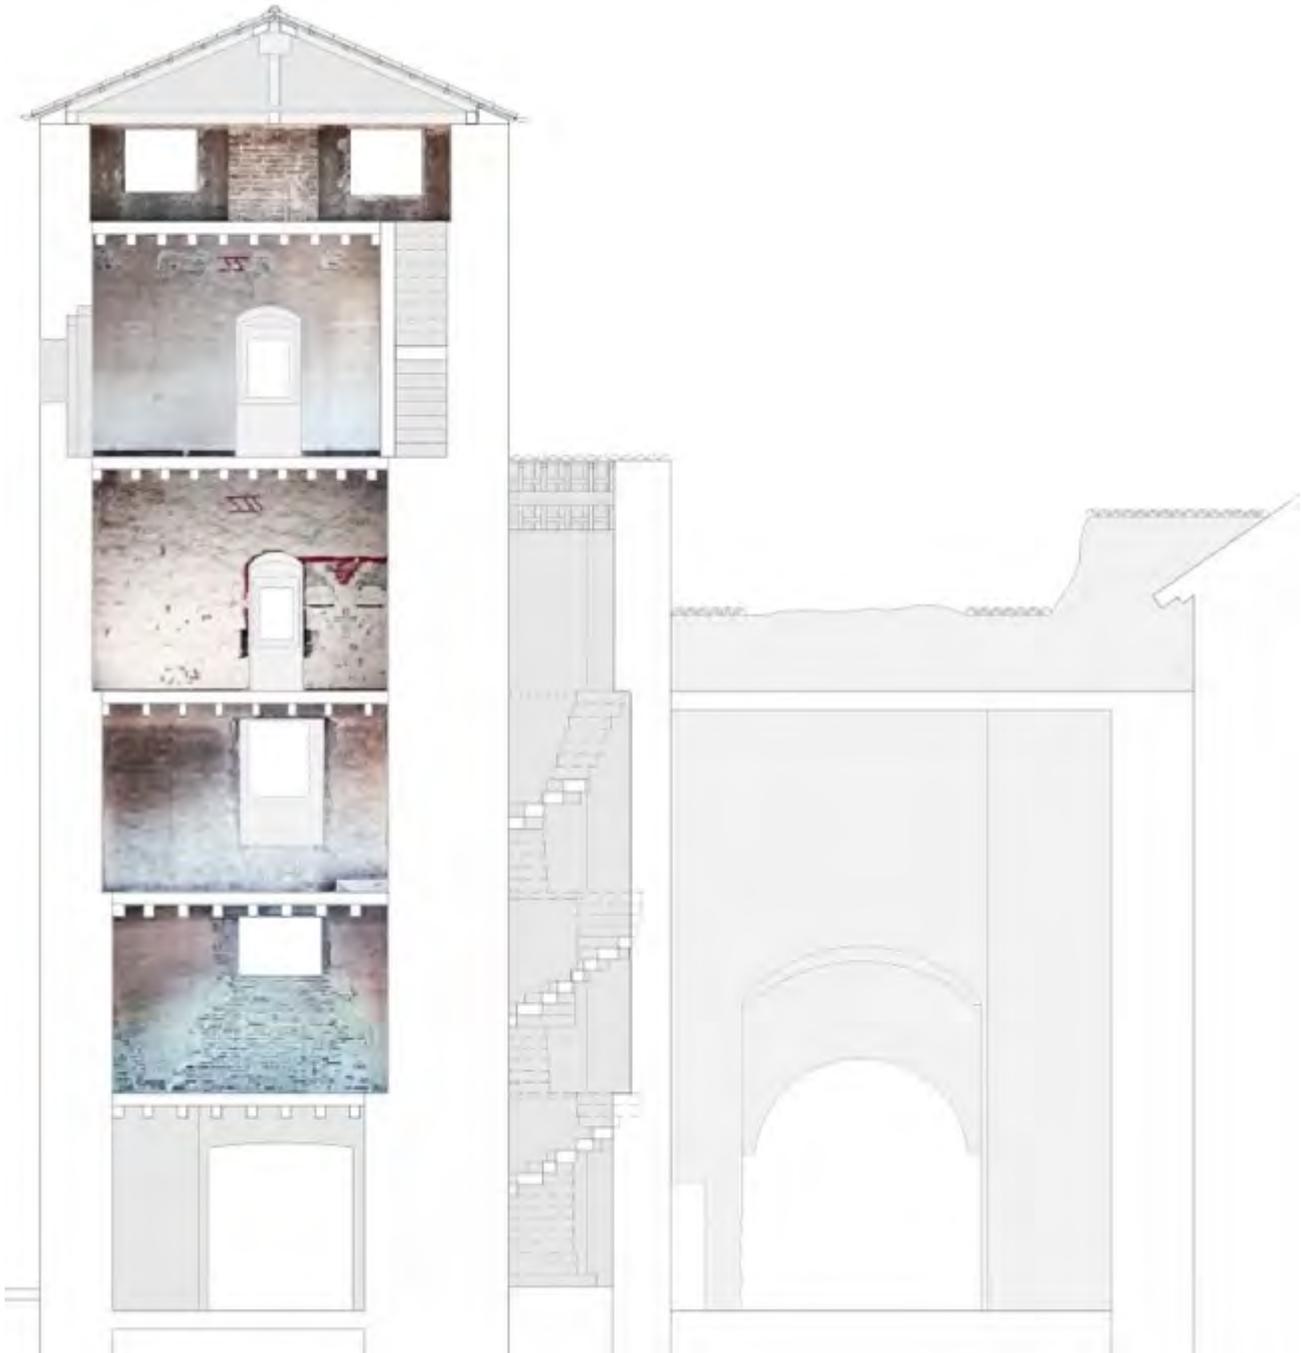
*Image 3: Section with image showing straightening of internal walls*

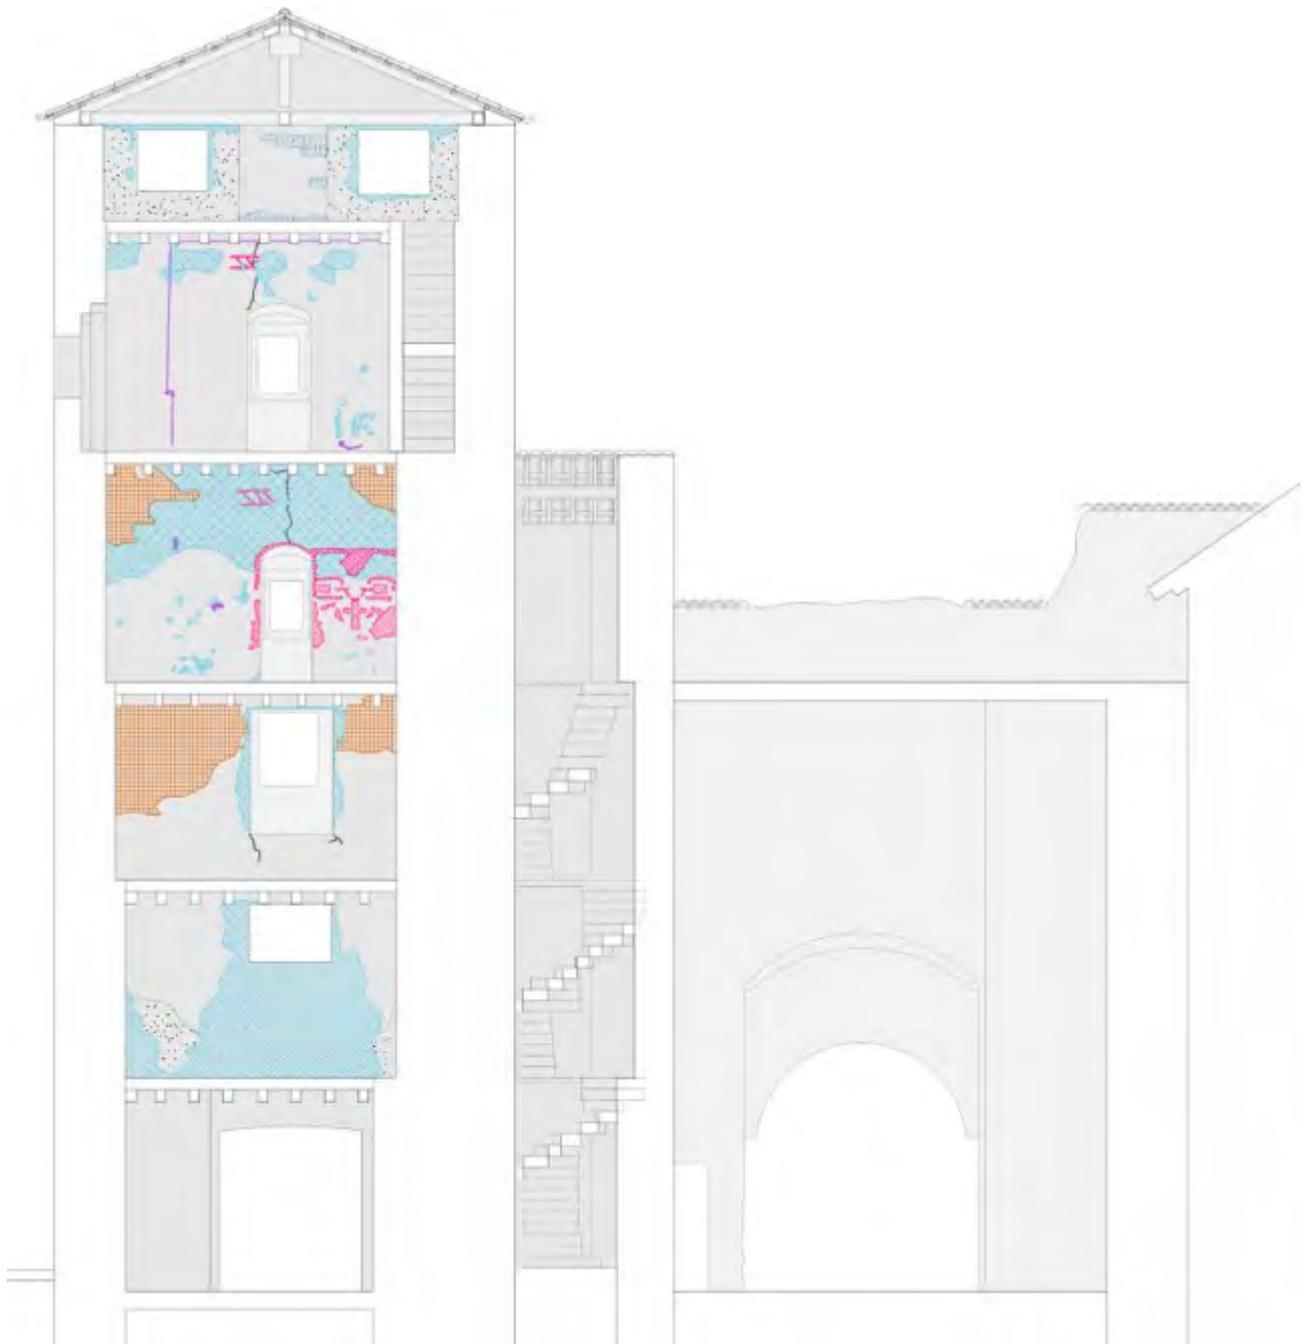
*Image 4: Degradation analysis through screening method*
