# TRANSNATIONAL MODEL OF SUSTAINABLE PROTECTION AND CONSERVATION OF HISTORIC RUINS

Best practices handbook

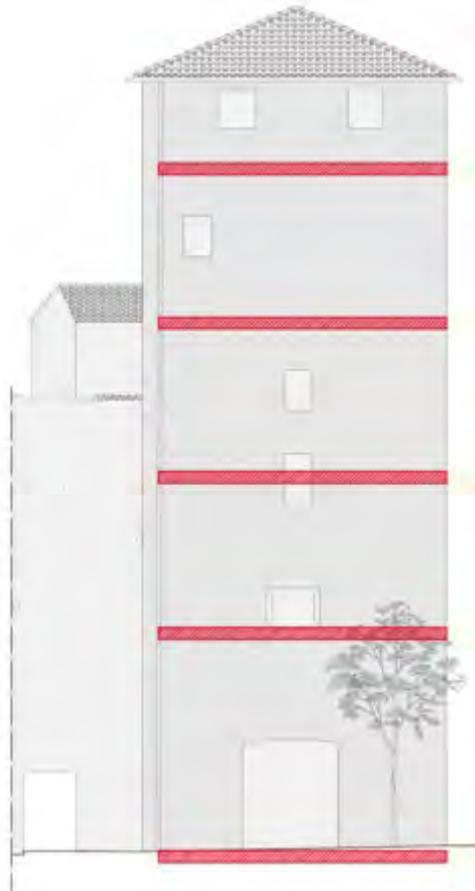
**Image 5:** *Position of the beams*

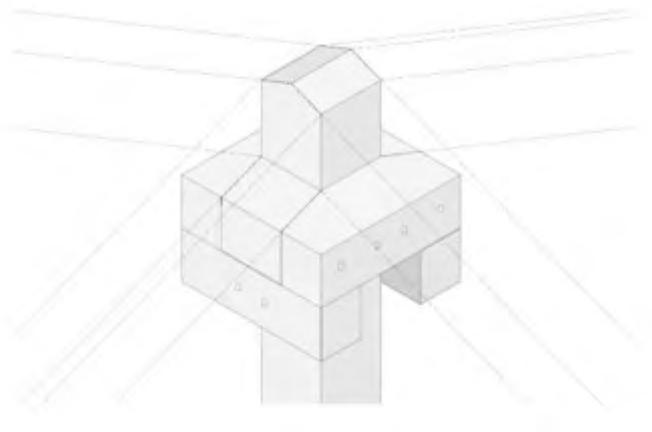
**Image 14:** *Trusses (detail)*

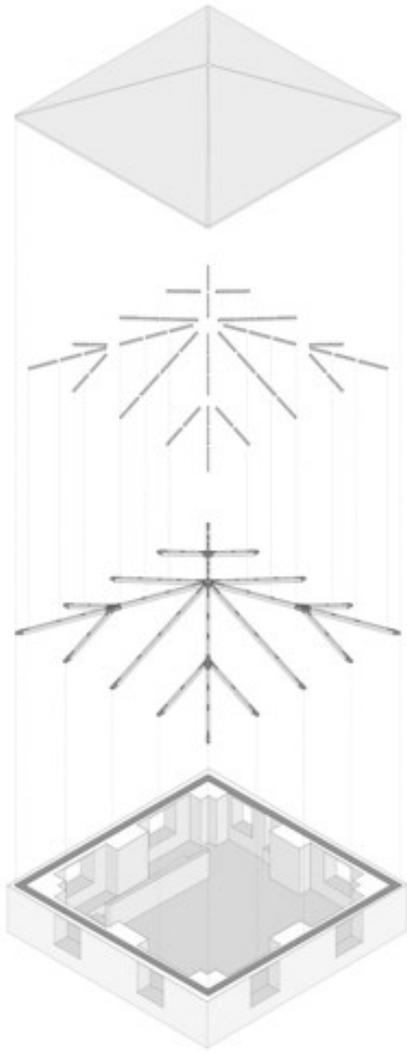
Image 15: Construction system
